PROJECT CASE STUDY: A 100+ YEAR OLD HAND-POWERED LIFT

PROJECT SCOPE AND OVERVIEW

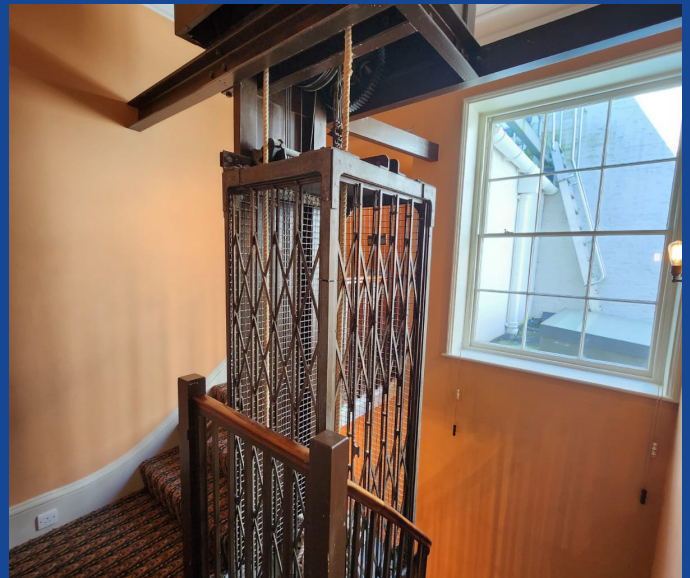
The overall outcome was a fully restored lift expected to last another 100 years. We had to re-make many gearbox parts due to excessive wear, which resulted in a much smoother and easier on-the-arm experience when travelling in the lift.

We matched the original paint colour for the lift car and painted the top steelwork to coordinate with the existing wooden guides. The car gates were overhauled in our workshop before powder coating to ensure easier opening and closing operation.
